OFFICERS CLUB Building No. 114

Sandy Hook Unit
Gateway National Recreation Area
Fort Hancock, New Jersey

HISTORIC STRUCTURE REPORT

June 2006

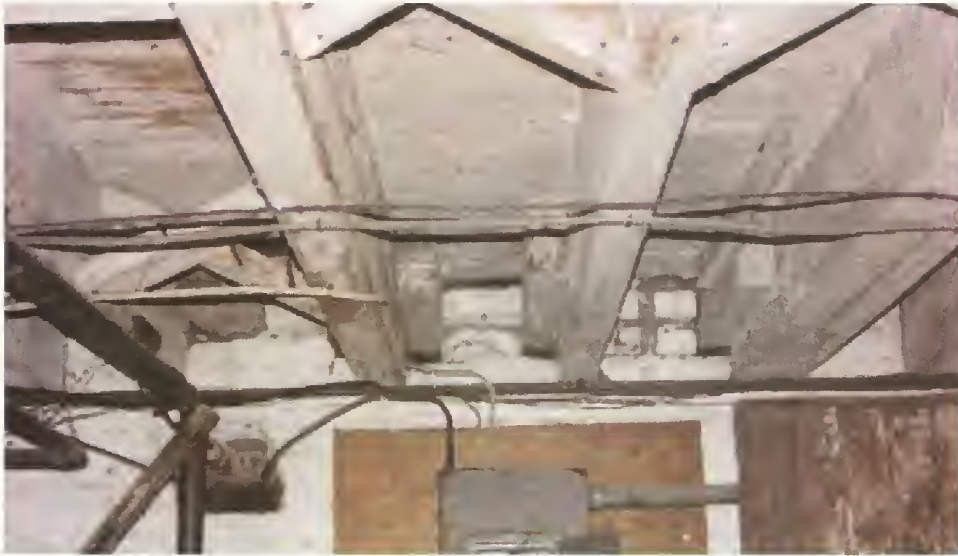
The proposed plans for the Officers Club showed entrances on both the north and south elevations of the rear ell. The south- elevation opening is now the location of an interior doorway. Examination of extant framing in the basement and alterations in the foundation suggests that a feature formerly projected from the building at this point, but was later removed and infilled with loose bricks (figs. 30- 31). Paint evidence, which indicates that the current doorway to the rear ell was a later alteration, supports the existence of the earlier opening on the south elevation. Evidence of the north- elevation exterior doorway was removed during alterations.

Figure 30. Officers Club, basement of rear ell, south wall, showing extant framing and brick infill that is evidence of earlier opening, 2005.

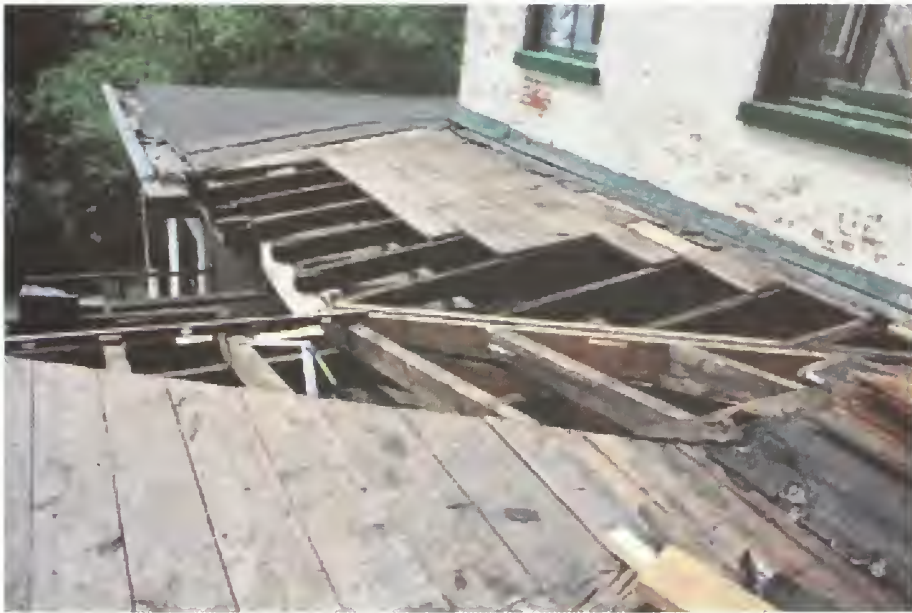
Figure 34. Officers Club, east façade, piazza roof, showing original framing and repairs, 1991.

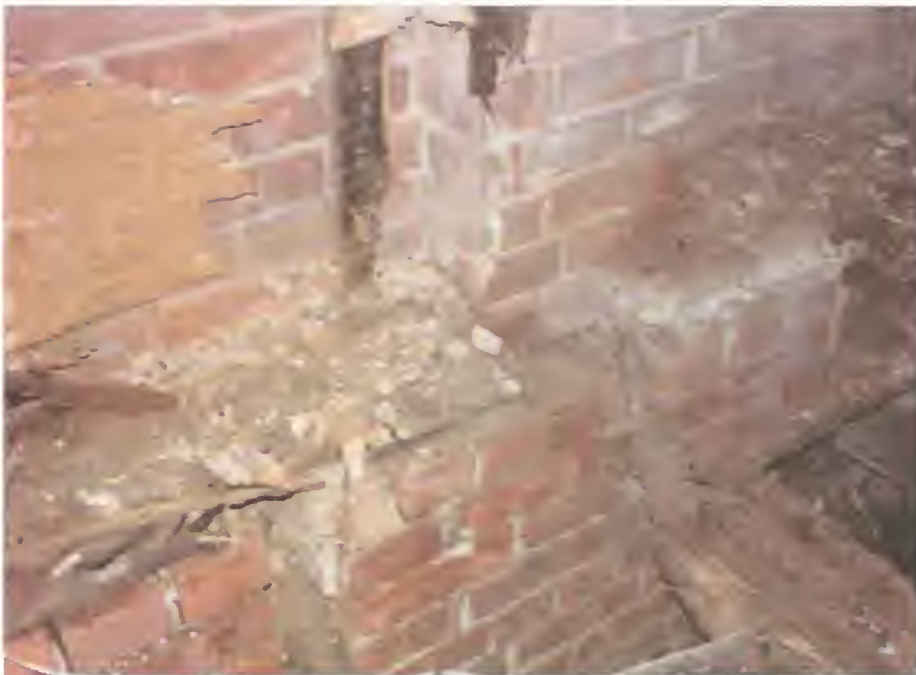
Figure 38. Officers Club, showing exterior bearing- wall construction at transition from first story to second story; also shows pockets in masonry for framing, 2005.

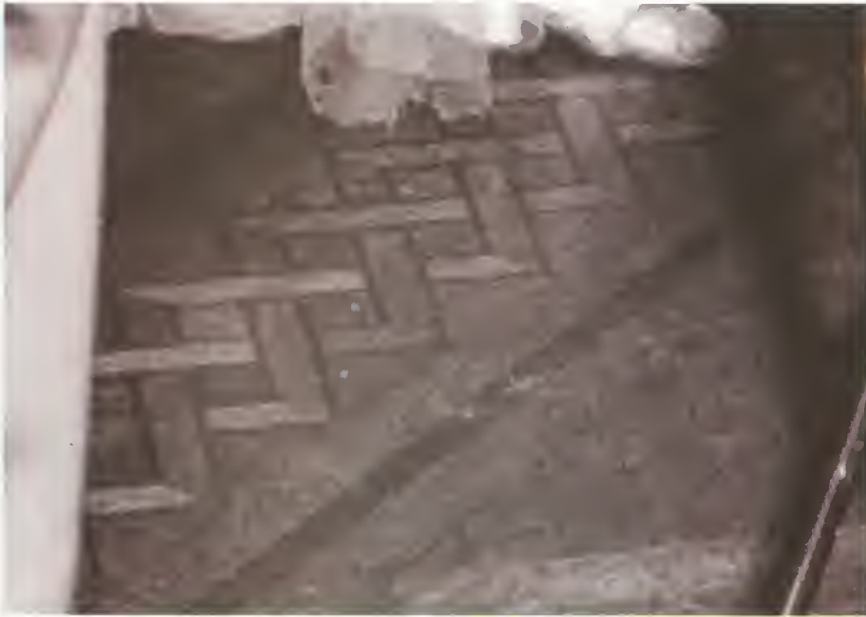
Figure 42. Officers Club, Men's Lounge (Room 104), detail from historic photograph showing parquetry floor no longer extant, ca. 1942.

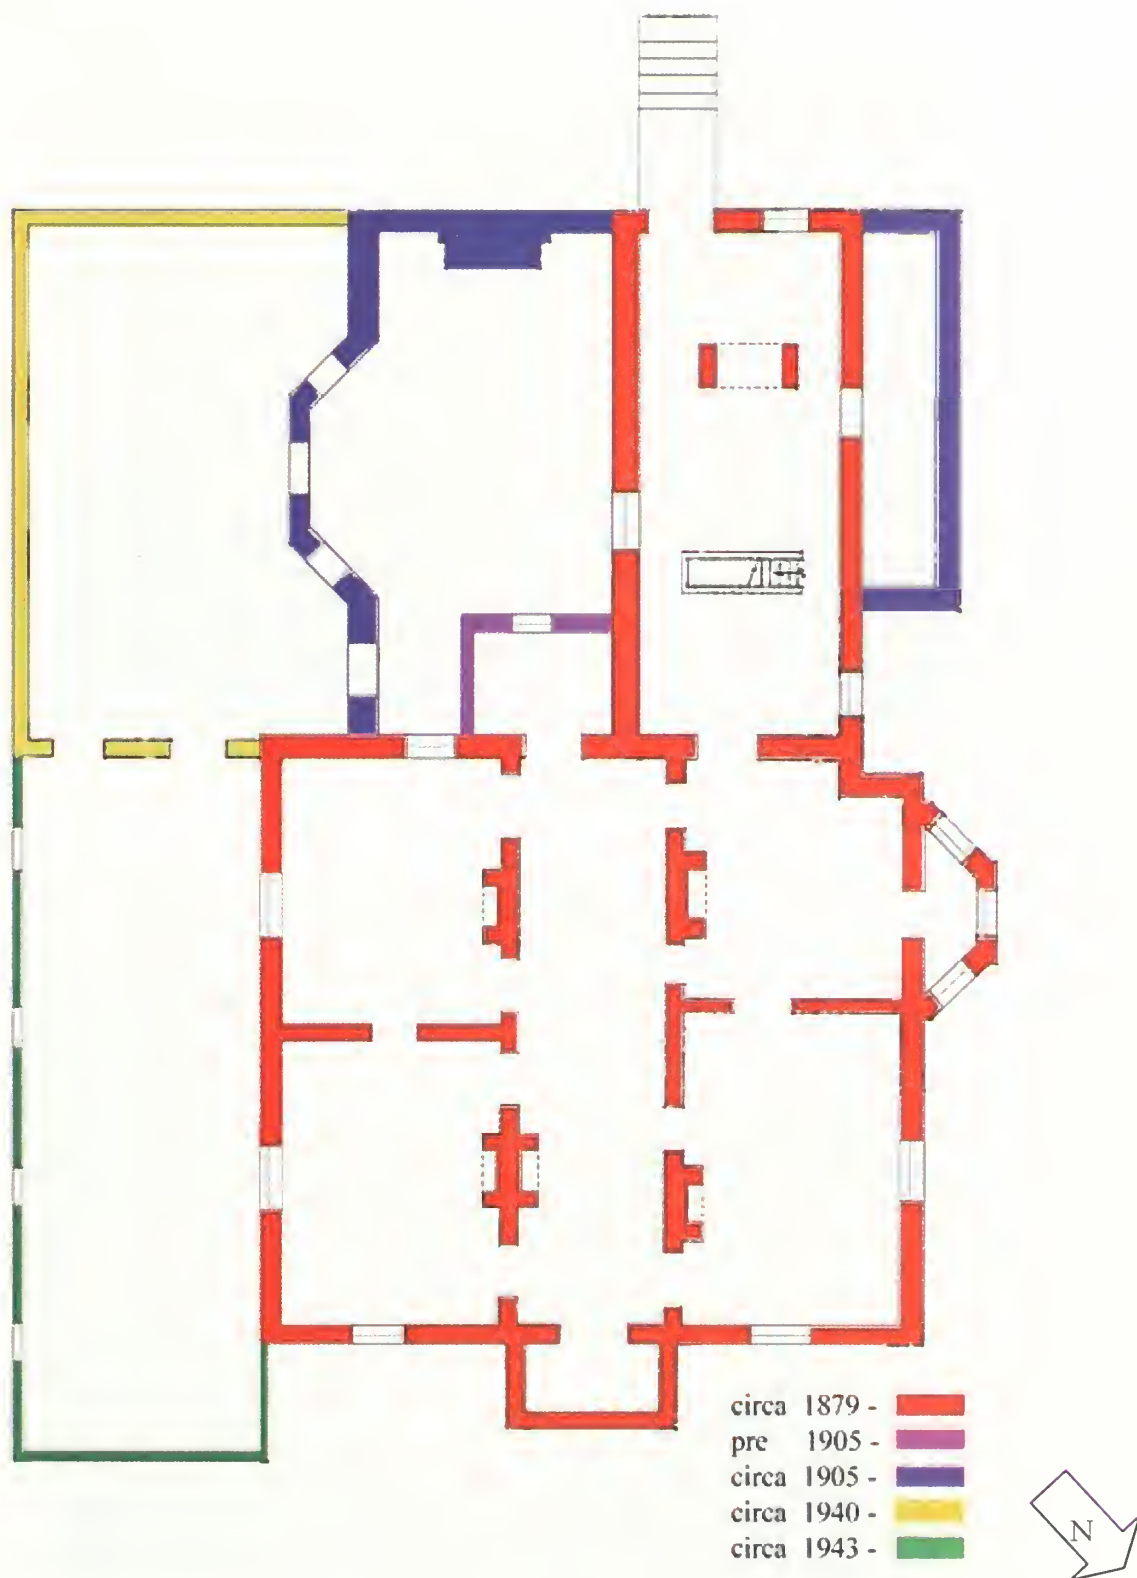
Examination of the existing foundation, and the bearing partition walls in the basement and on the first and second stories of the rear ell, shows further evidence of the addition (fig. 55). The south exterior wall of the original rear ell, which was brick and extended from the basement level through the second story, became the extant partition wall between the Kitchen (Room 105) and the Dining Room (Room 106). The foundations of the main block of the structure and the original rear ell were connected and had full basements, which were accessed from the west- elevation bulkhead of the rear ell. By contrast, the basement of the addition to the rear ell was built with only a crawl space, and was only accessible through an existing basement window.

Figure 55. Officers Club, basement plan illustrating original appearance and alterations (not to scale).

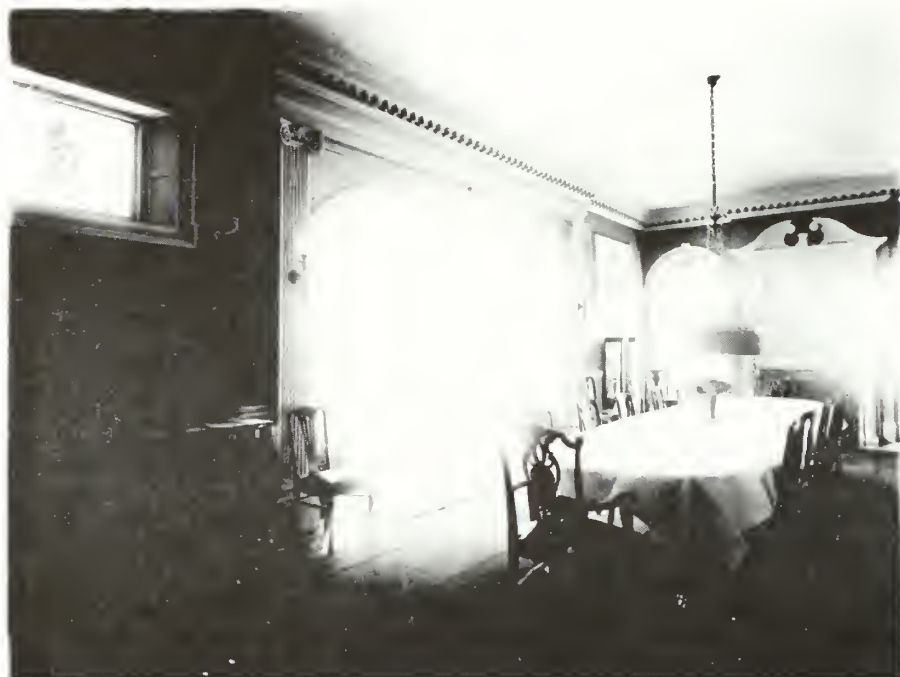
Upon close examination, one photograph reveals the outlines of a large bay window facing south (fig. 56). This is supported by the shape of the ca.- 1905 foundation, which was constructed with a three- sided projection on the south elevation (fig. 55). The bay was designed to take full advantage of the southern exposure of the Dining Room (Room 106). The bay- window opening was framed with a classical archway composed of a large segmental arch with Composite- order pilasters and entablature. The archway was balanced by a symmetrically placed arch on the north wall, which framed a niche for a sideboard and, at the time of the photograph, a moose head.

Figure 56. Officers Club, Dining Room (Room 106), view of south and west walls, ca. 1905.

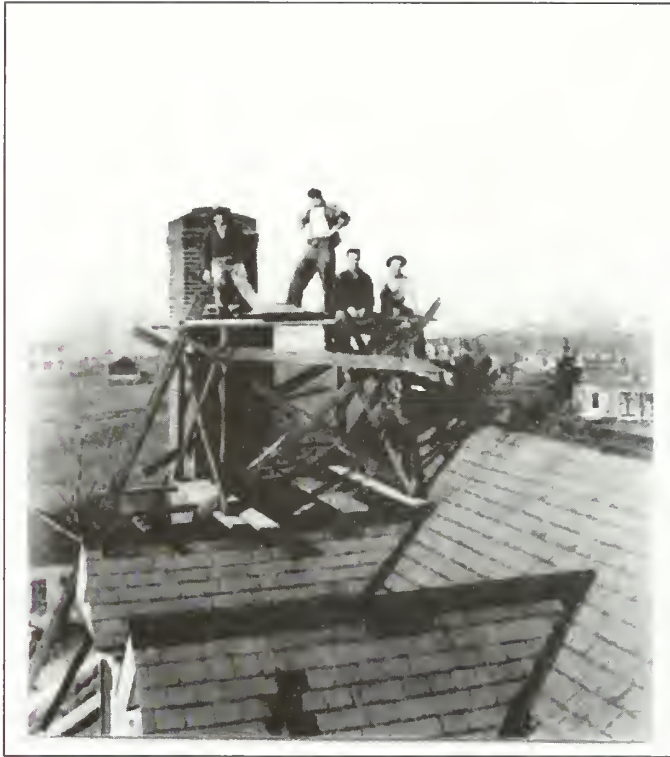
Figure 67. Officers Club, chimney work on rear- ell gable roof, ca. 1937.
